BNAPS News

BNAPS News Vol 12 Iss 4 – July 2022

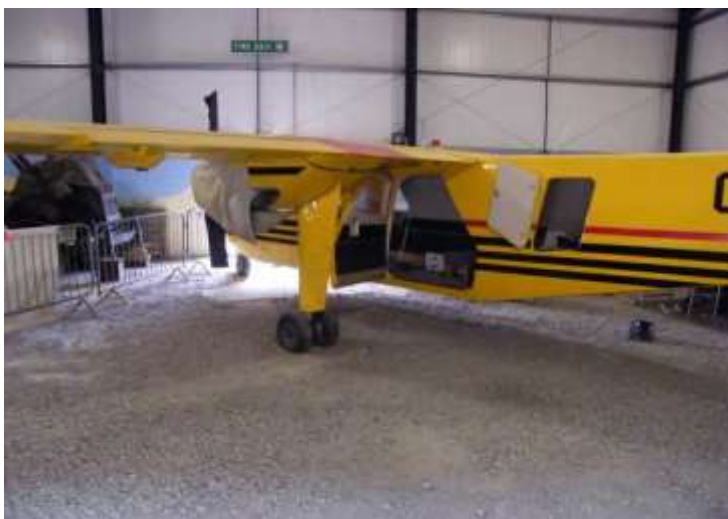
View of museum area after being cleared to provide access for laying tarmac floor covering.

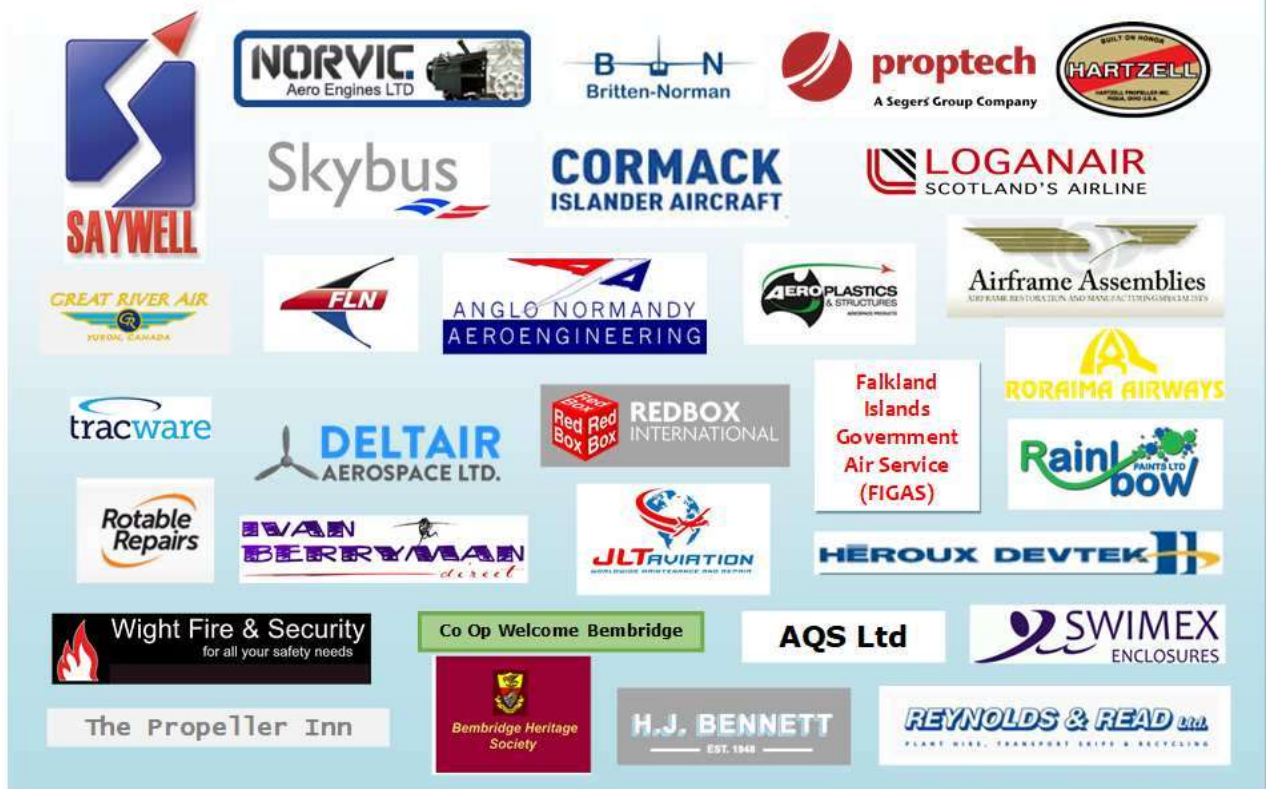
Islander G-AVCN Recovery and Restoration

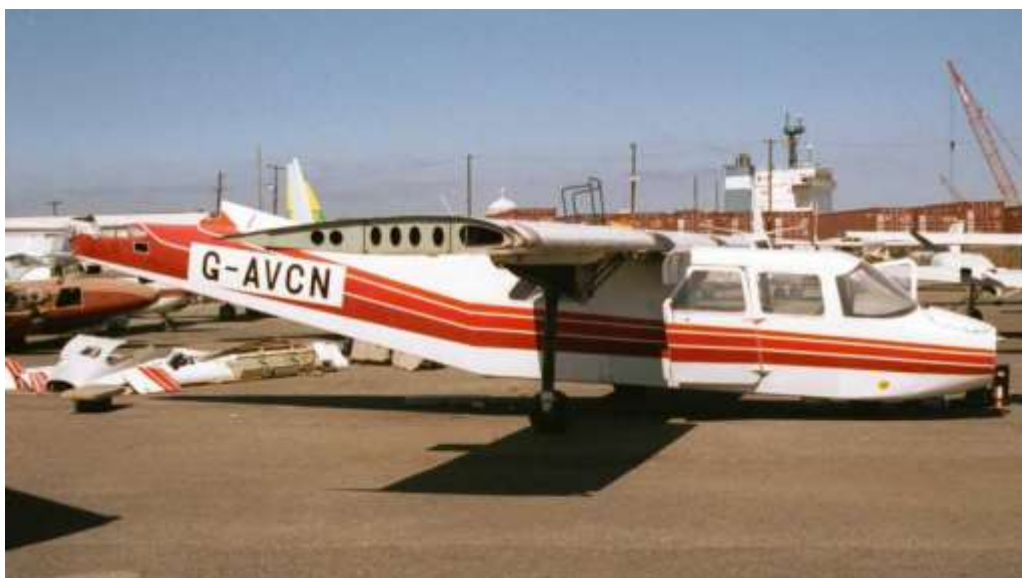
Islander G-AVCN in the process of being dismantled at Isla Grande Airport, Puerto Rico in January 2000 (BN Historians).

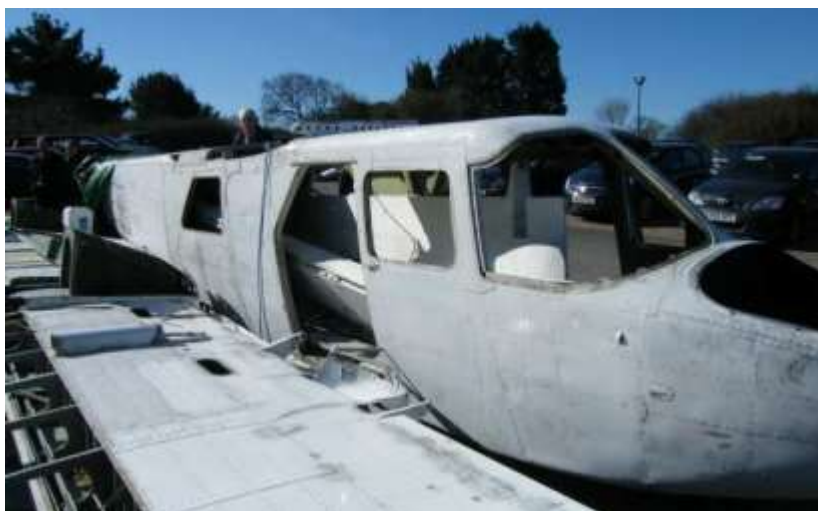
Dismantled Islander G-AVCN fuselage in open storage at Bembridge March 2010.

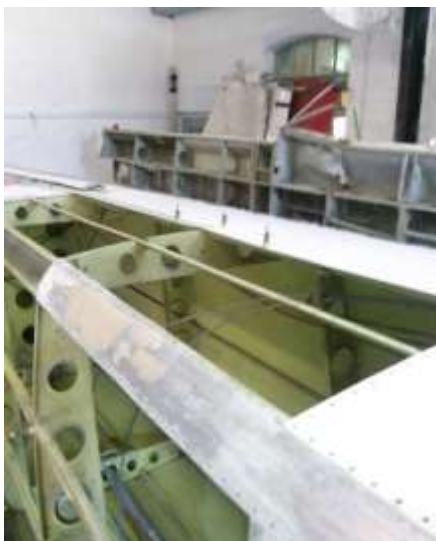
Fuselage aft roof skin slit fore and aft showing damaged starboard side removed. Also showing replacement upper corner skin in place.

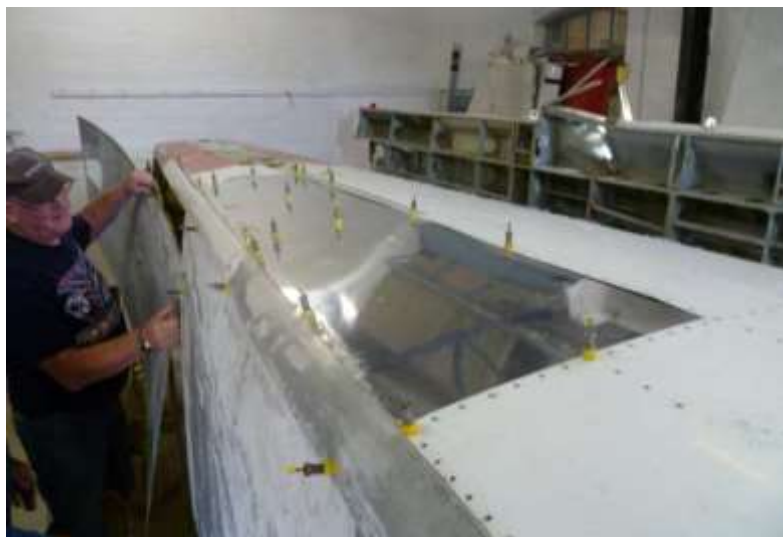
New starboard rear roof skin fitted to fuselage ready for riveting.

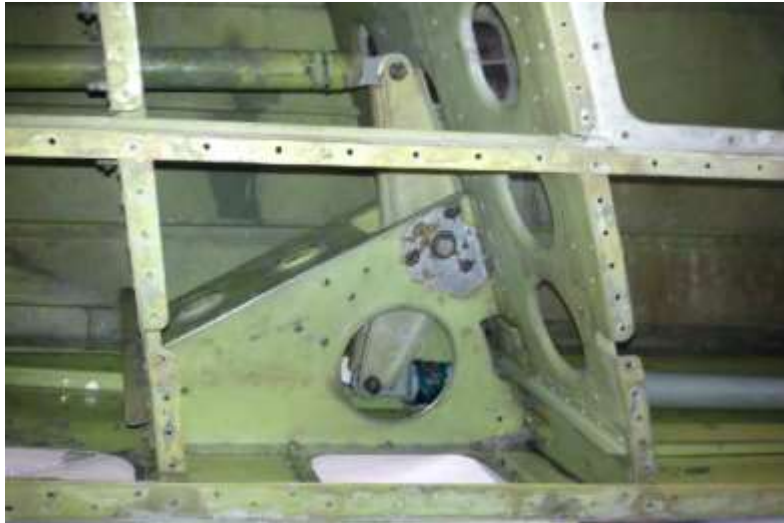
Elevator rods in place in rear fuselage and replacement elevator bell-crank installed.

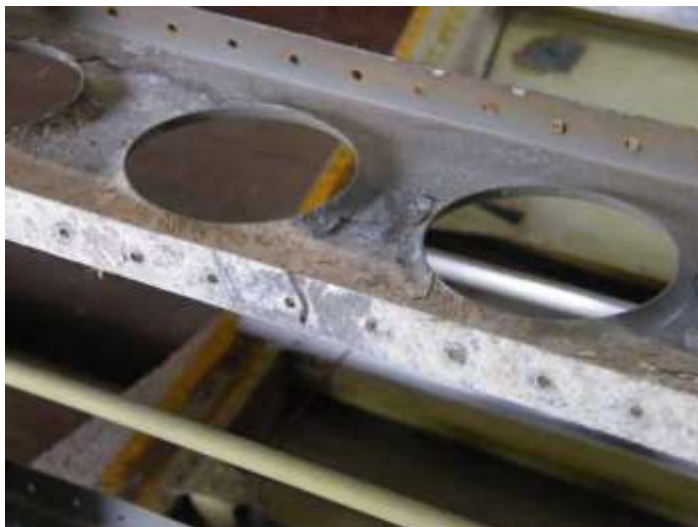
Corrosion and damage to frames and longerons in underfloor structure.

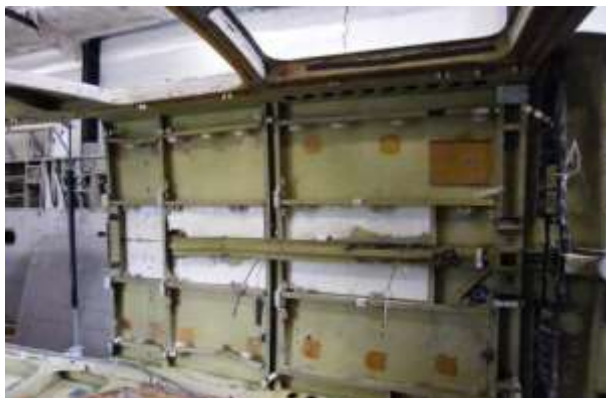
Damage to internal roof structure and top skin.

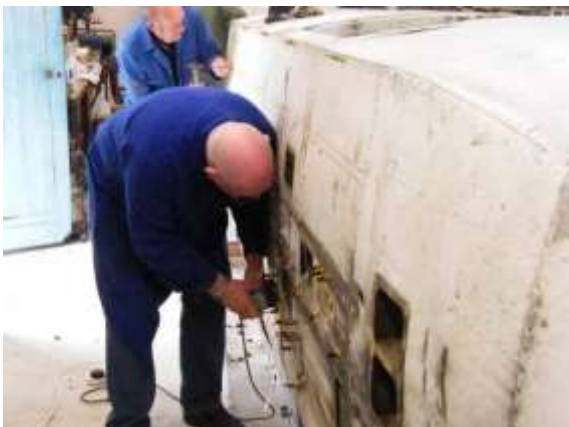
An angle grinder was used by Paul Thomasson to remove the rusted in skin clips in the fuselage bottom skin.

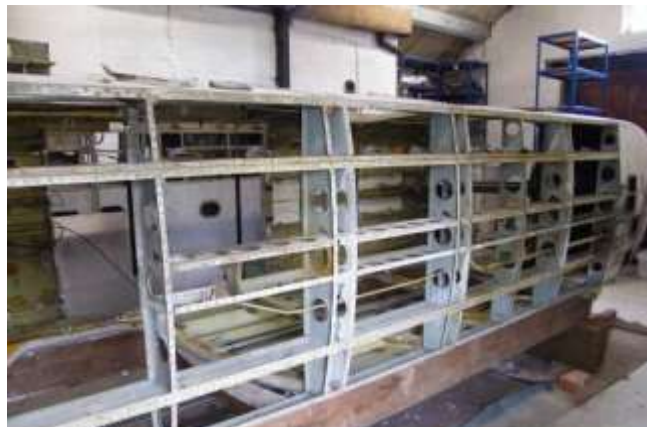
Fuselage bottom skin finally removed.

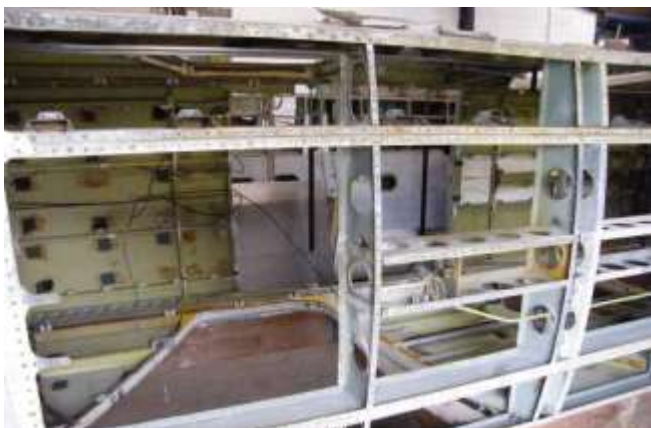
Damaged underfloor intercostals were removed for repair.

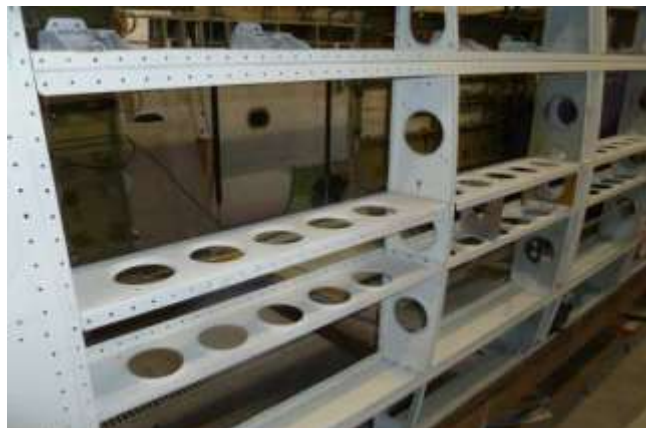
Repaired intercostals back in place and sprayed with etch-prime.

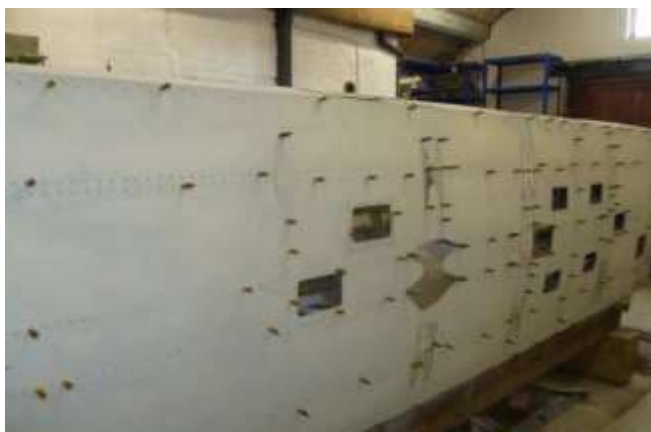
Refitting the repaired fuselage bottom skin.

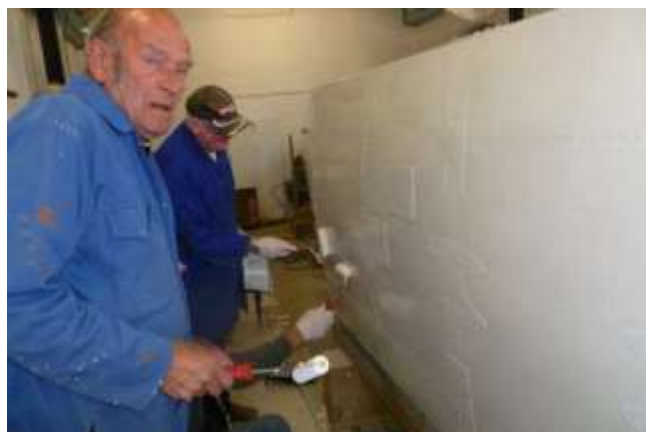
Fuselage bottom skin secured in place and being painted with undercoat by Keith Winter (left) and Paul Thomasson.

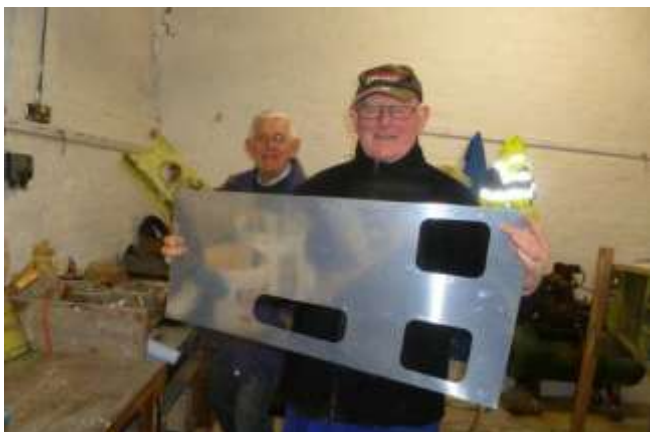
Paul Thomasson with the re-manufactured fuselage aft bottom skin ready for etch-prime.

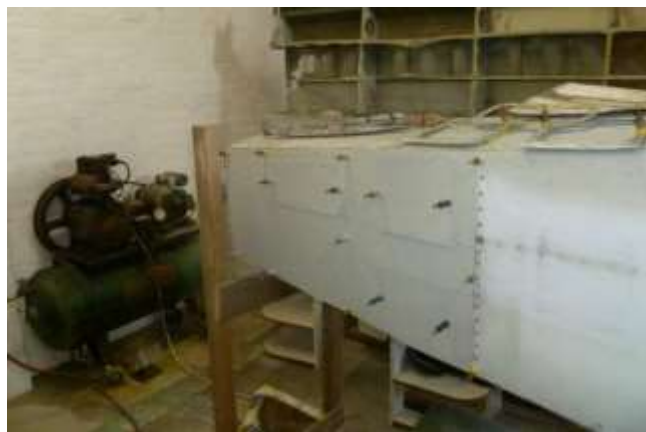
New fuselage aft bottom skin riveted in place, complete with inspection and access panels.

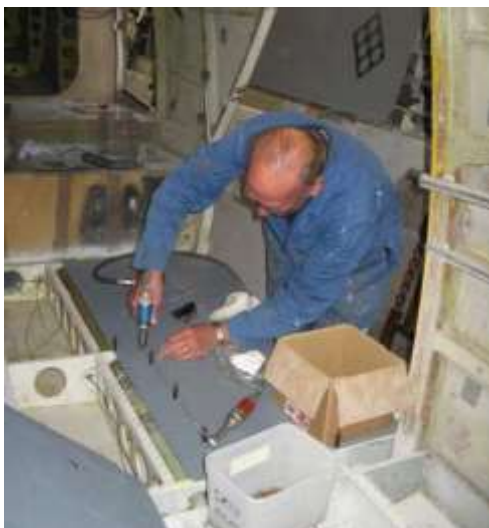
Left - Keith Winter starting to fit the new cabin floor onto the refurbished underfloor structure - aft port section.

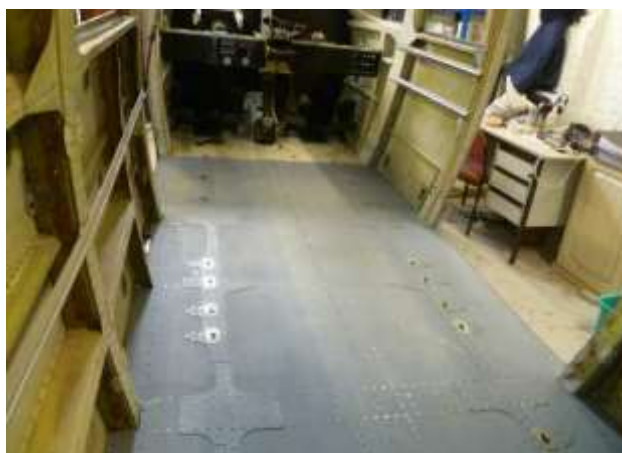
Complete new cabin floor installed with long doublers and seat key plates.

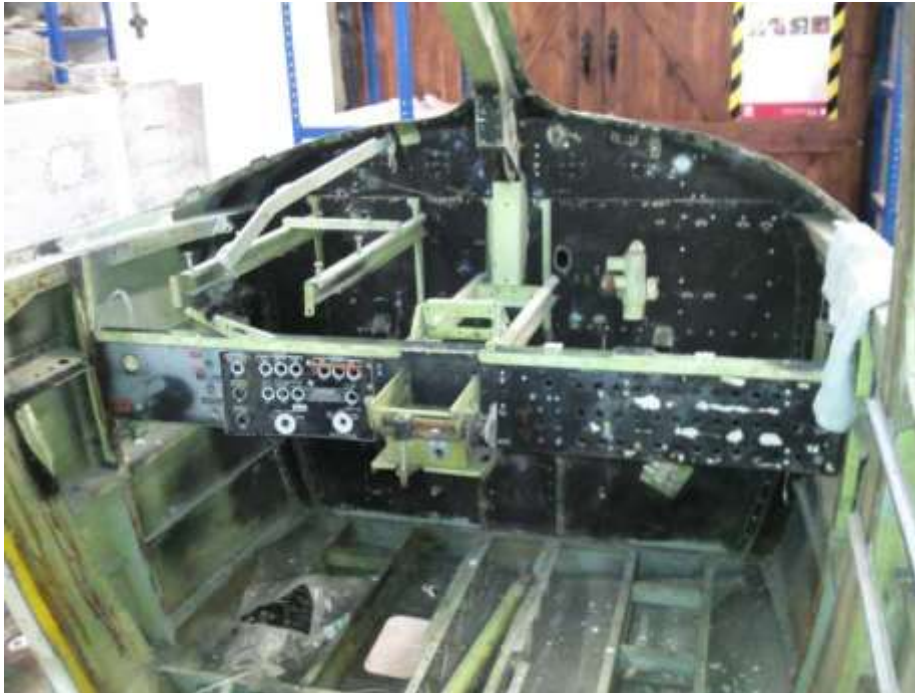
View of cockpit area prior to starting restoration.

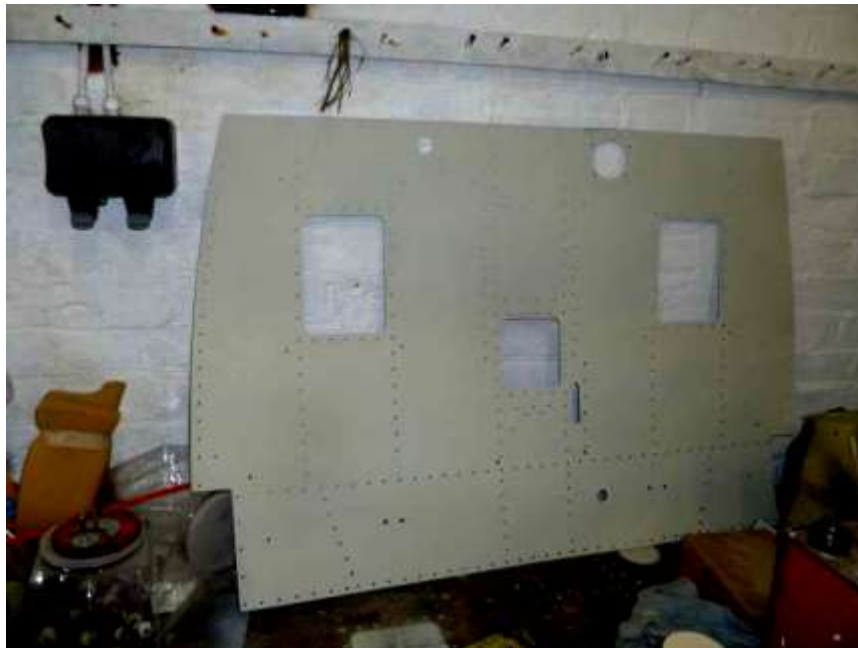
Cockpit floor decorruded and repaired ready for fitting.

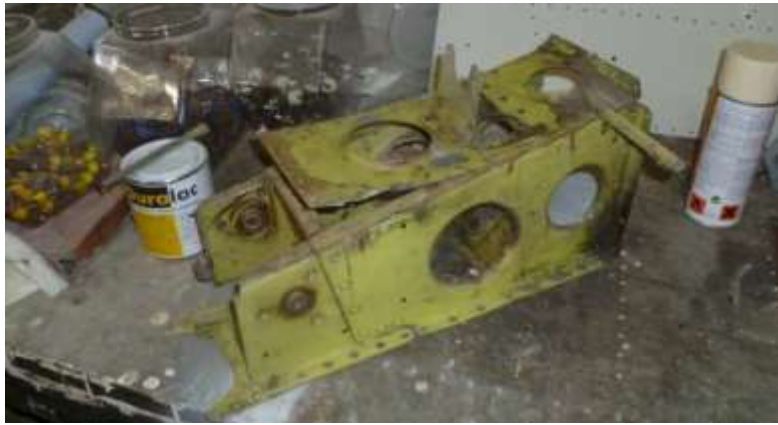
Control yoke lower mounting structure prior to restoration and reassembling in the cockpit floor.

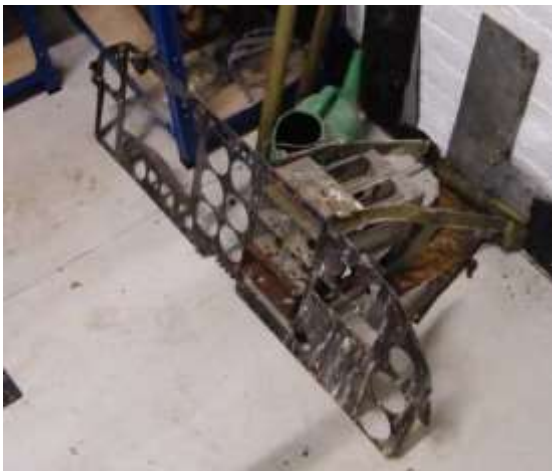
Instrument panel awaiting restoration.

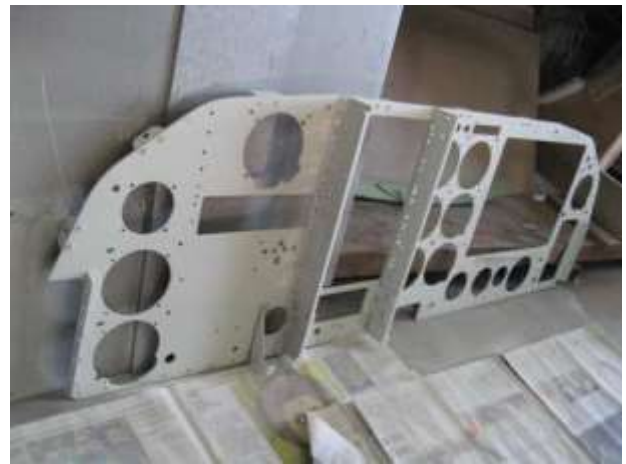
Instrument panel repaired and painted in primer awaiting satin black topcoat.

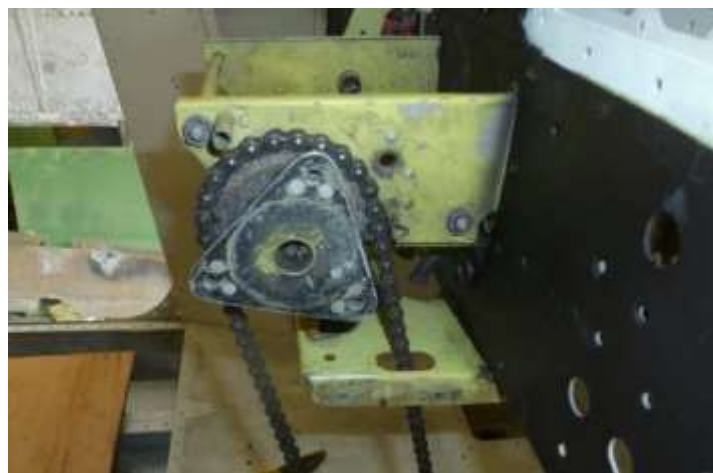
Trial installation of elevator trim mechanism showing operating chain in cockpit central console.

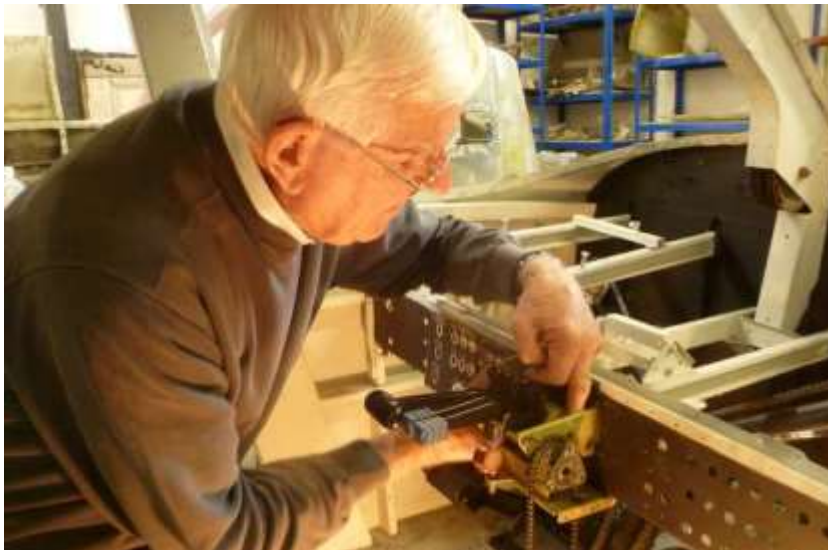
Bob Ward working on installing the six engine control levers into the cockpit throttle box.

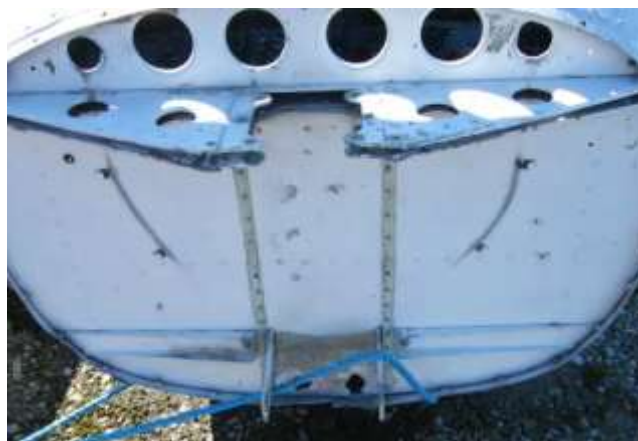
Frame 19 with nose wheel mounting structure missing.

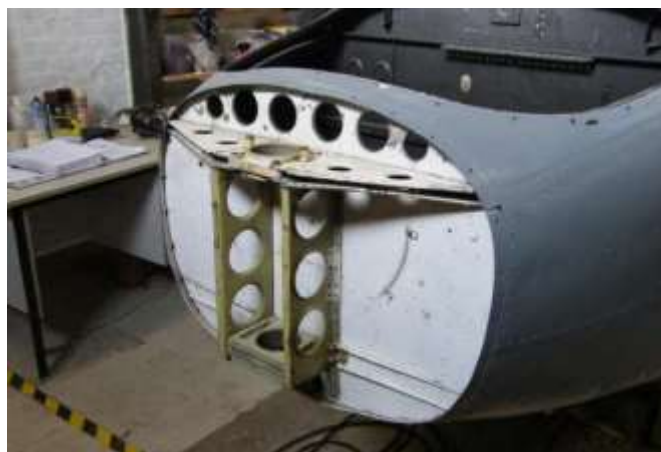
Frame 19 with nose wheel mounting structure re-instated.

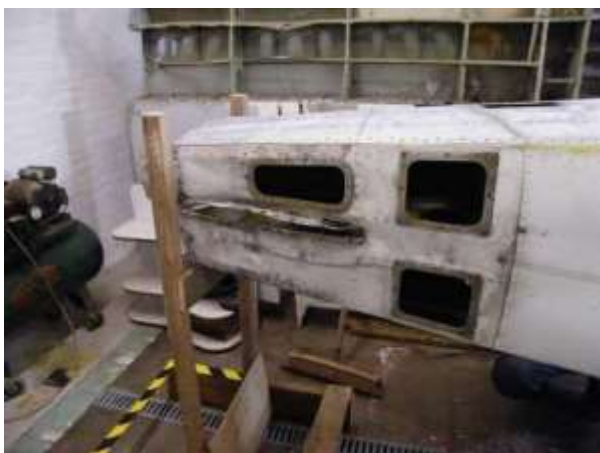
Missing tail bumper on the bottom of the aft fuselage.

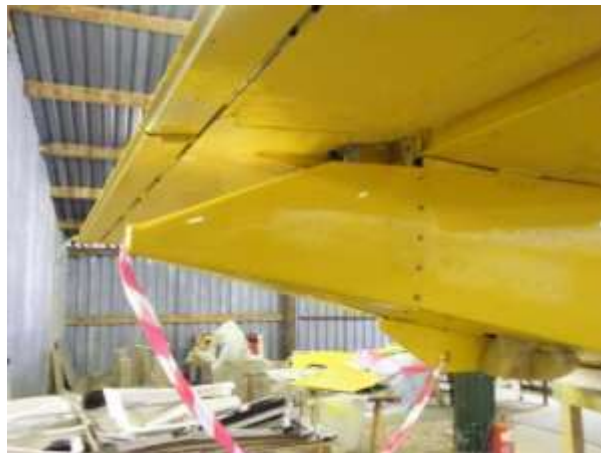
Refurbished rear tail bumper in place (Post final painting).

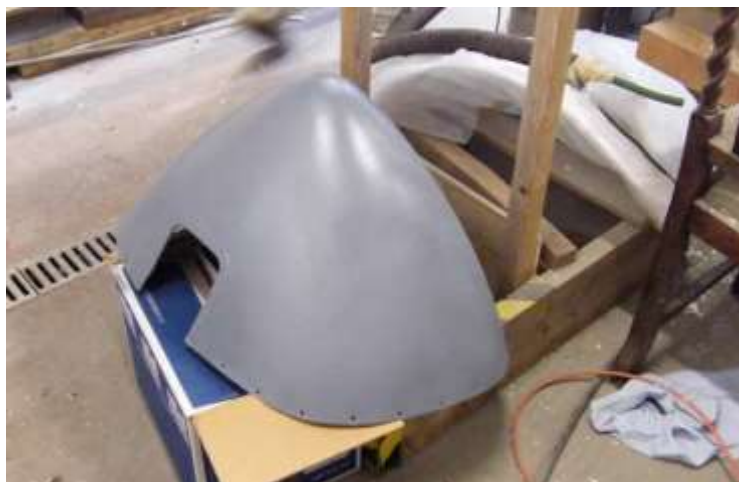
Refurbished nosecone undercoated ready for top coat painting.

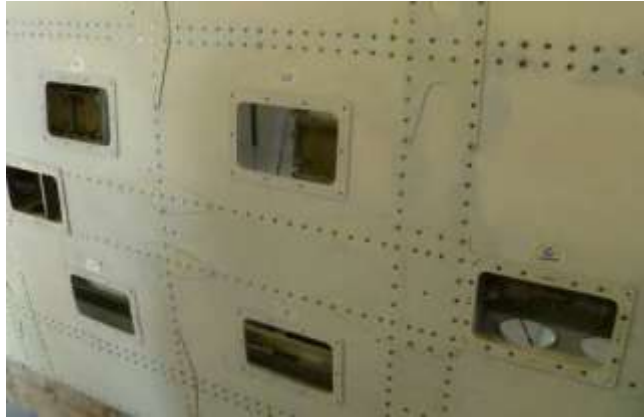
Repaired fuselage bottom skin showing inspection and access panel mounting doublers repaired and ready for fitting panels after final painting.

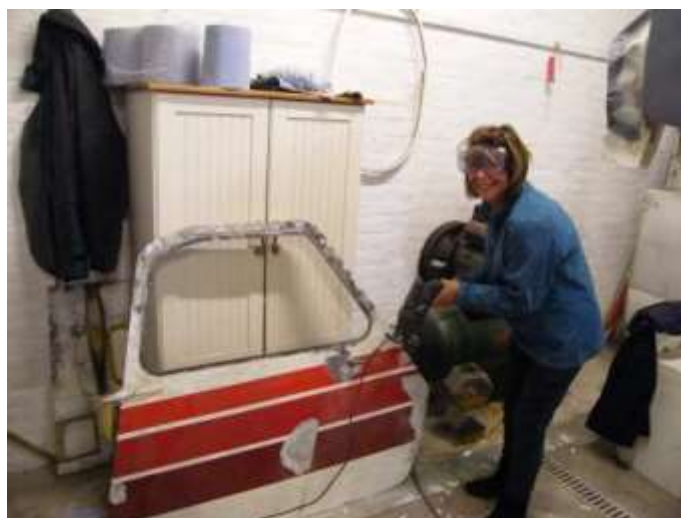
Jeni Gallagher paint stripping and repairing Port Rear Passenger Door.

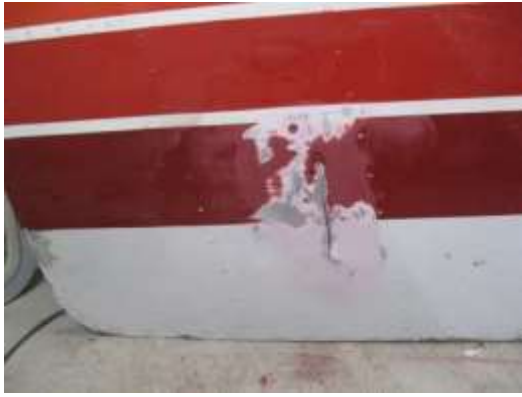
Damage to inner and outer skins of Starboard Passenger Door.

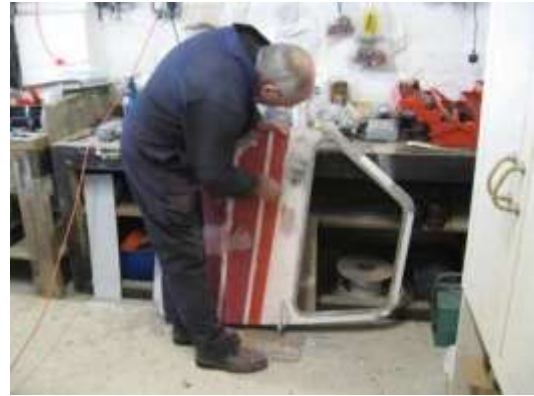
Bob Wealthy working on repairing the Starboard Passenger Door.

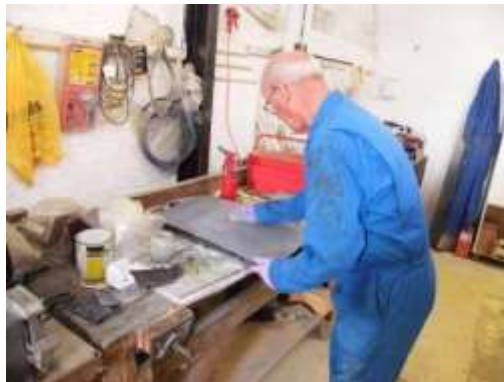
Roger Young working on surface preparation of the Baggage Bay Door.

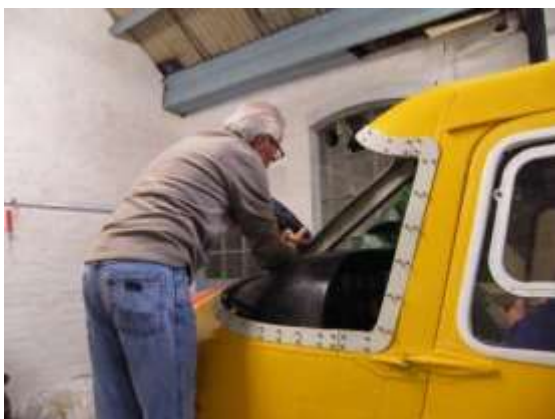
Paul Brook working on installation of the windscreen glazing.

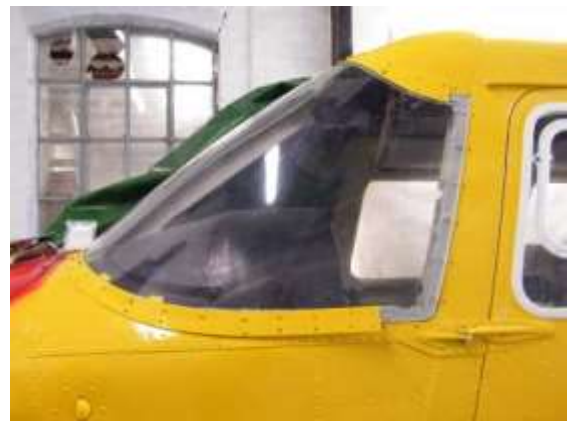
View of windscreen after installation.

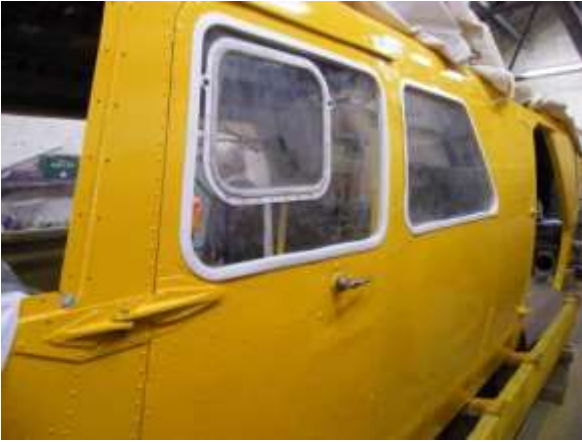
Pilot's door and port side passenger window glazing installed.

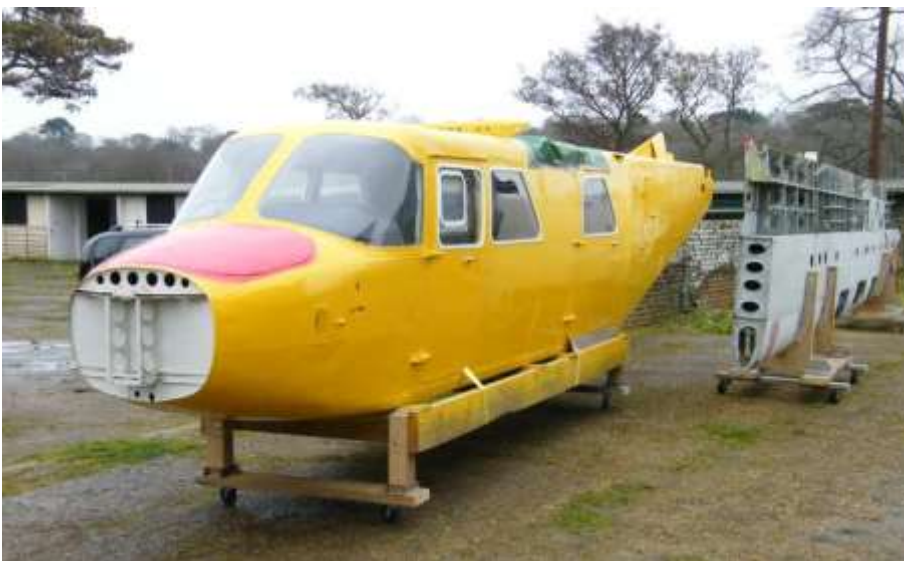
View of the fuselage ready to be moved from the Harbour Farm workshop in March 2016. At this stage all work to refurbish the fuselage structure was complete, window glazing and doors had been installed. The nosecone and tailcone were not fitted to avoid risk of damage during transport to the Brickfields workshop.

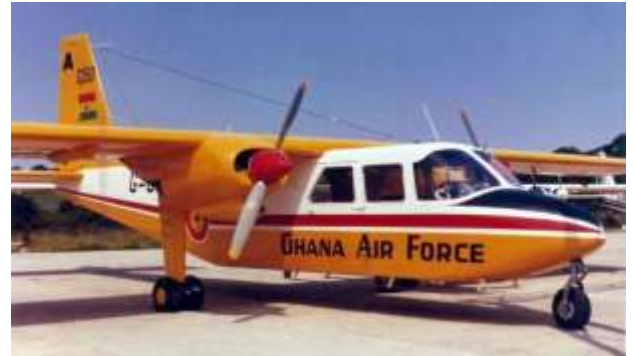
Islander c/n 333 G-BAZW/G350 at Bembridge pre-delivery to Ghana Air Force July 1973 (Norman Hobbs).

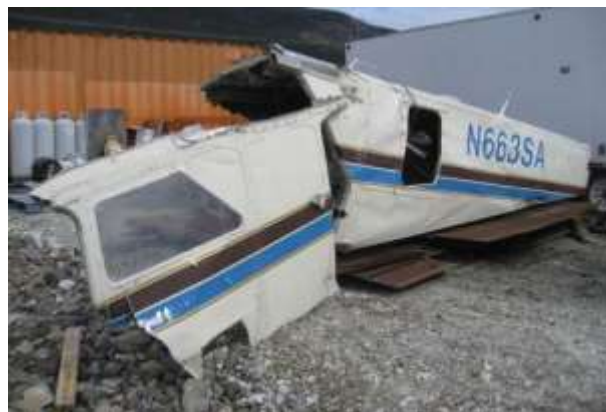
Remains of Islander c/n 4 N663SA in open storage on an industrial estate near the Klondike Highway.

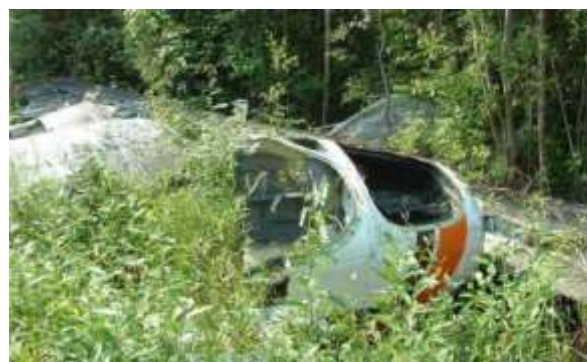
Islander C-GPCF, c/n 39, wreckage at Lammers Airstrip in 1990s (Neil Murtzell).

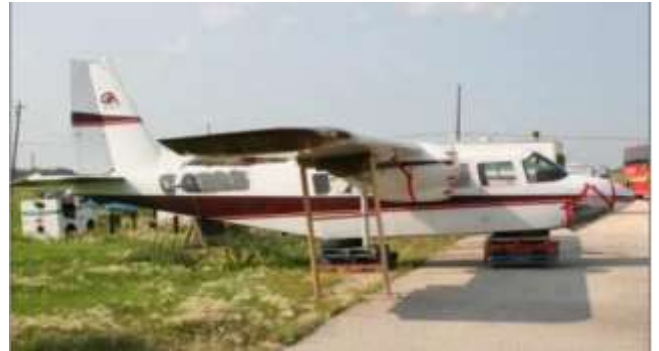
Islander C-GBRB, c/n 893, partially dismantled at St Andrew's Airport c 2008 (Bill Teasdale).

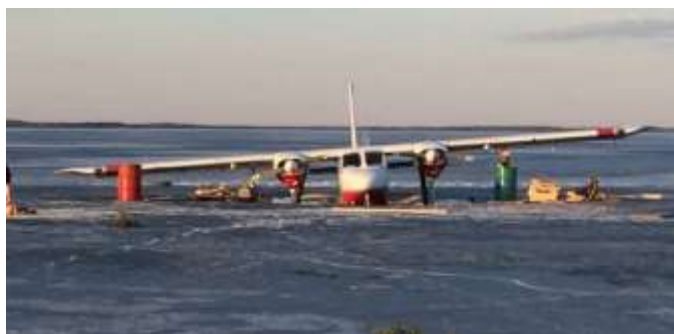
Islander C-GPPP, c/n 423, stranded on the ice covered Atkinson Lake

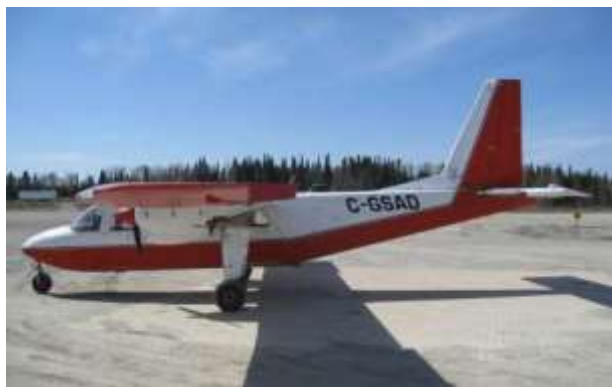
Islander C-GSAD, c/n 7, parked on the apron at St. Theresa Airport, North Manitoba.

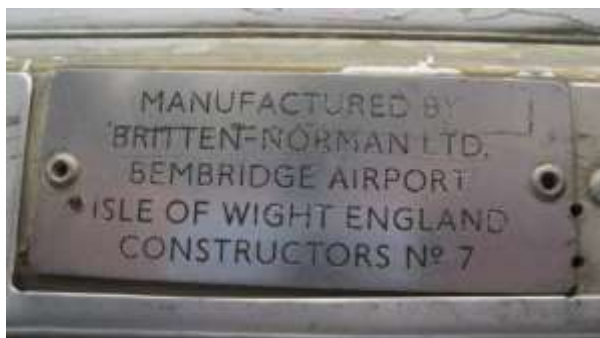
Islander c/n 7 manufacturer's ID plate

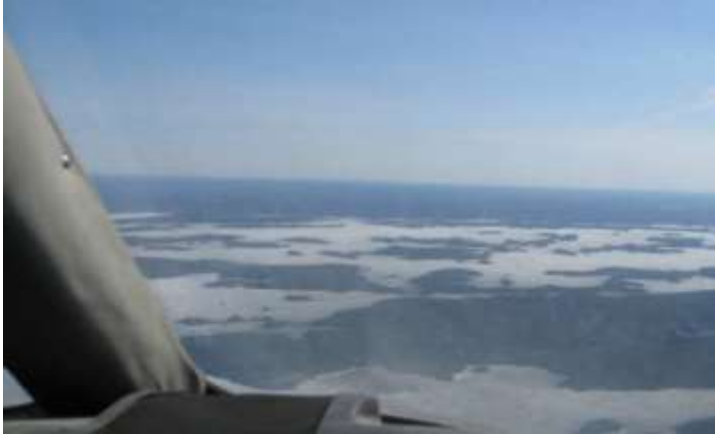
View in clear conditions during the cruise at 2500 - 3000 ft

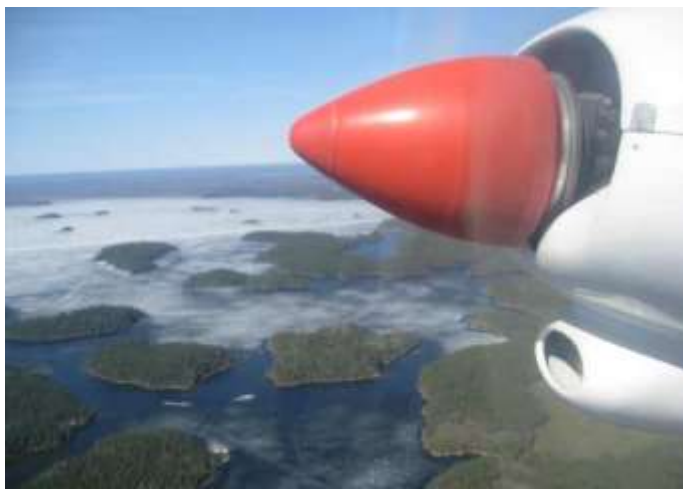
View of snow covered local terrain.

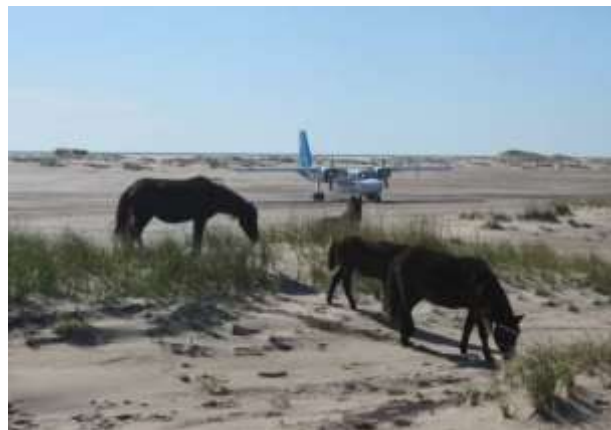
The beach landing area is shared with local Sable Island wildlife (Parks Canada)

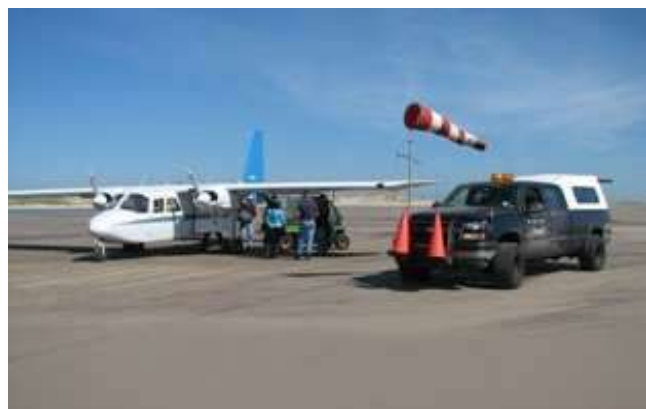
Islander C-GILS, c/n 416, loading getting ready to fly out from Sable Island beach (Sable Aviation).

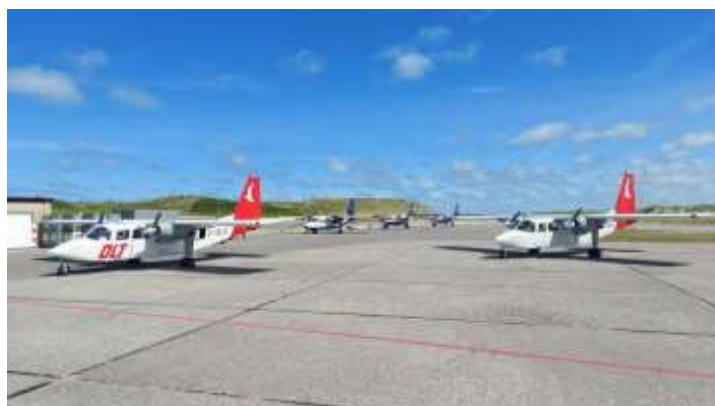
Jan-Lüppen Brunzema 1952 -2022
